Alstede Farms, LLC

76 Route 24
Chester, New Jersey 07930

Chester Township, Morris County

8 Areas of Concern

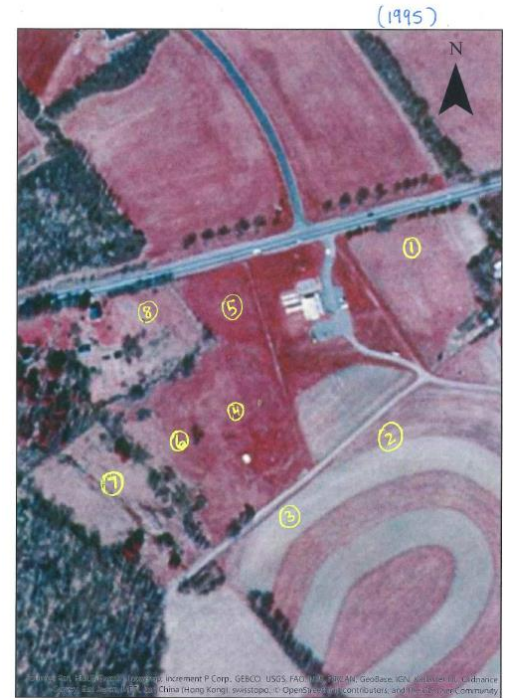
Area 1: No NJDEP Land Use regulated areas. Per ArcGIS Pro aerial photography, this area appears to be a pre-disturbed field dating back to 1995 and maintained as a paddock/pasture. It is also used for seasonal parking.

Area 2: No NJDEP Land Use regulated areas. Per ArcGIS Pro aerial photography, this area appears to be a pre-disturbed field dating back to 1995 and maintained as a crop production field. It is also used for seasonal parking.

Area 3: No NJDEP Land Use regulated areas. Per ArcGIS Pro aerial photography, this area appears to be a pre-disturbed field dating back to 1995 and maintained as a crop production field. It is also used for seasonal parking.

Area 4: No NJDEP Land Use regulated areas. Per ArcGIS Pro aerial photography, this area appears to be a pre-disturbed field dating back to 1995 and maintained as a paddock/pasture. It is also used for seasonal parking.

Area 5: No NJDEP Land Use regulated areas. Per ArcGIS Pro aerial photography, this area appears to be a pre-disturbed field dating back to 1995 and maintained as a paddock/pasture. It is also used for seasonal parking.

Area 6: No NJDEP Land Use regulated areas. Per ArcGIS Pro aerial photography, this area appears to be a pre-disturbed field dating back to 1995 and maintained as a paddock/pasture. It is also used for seasonal parking.

Area 7: Wetland ditch in area however, the agricultural crossing was authorized under a Forest Management Plan. No expansions of the field into regulated areas. Per ArcGIS Pro aerial photography, this area appears to be a pre-disturbed field dating back to 1995 and maintained as a crop production field. It is also used for seasonal parking.

Area 8: No NJDEP Land Use regulated areas. Per ArcGIS Pro aerial photography, this area appears to be a pre-disturbed field dating back to 1995 and maintained as a crop production field. It is also used for seasonal parking.

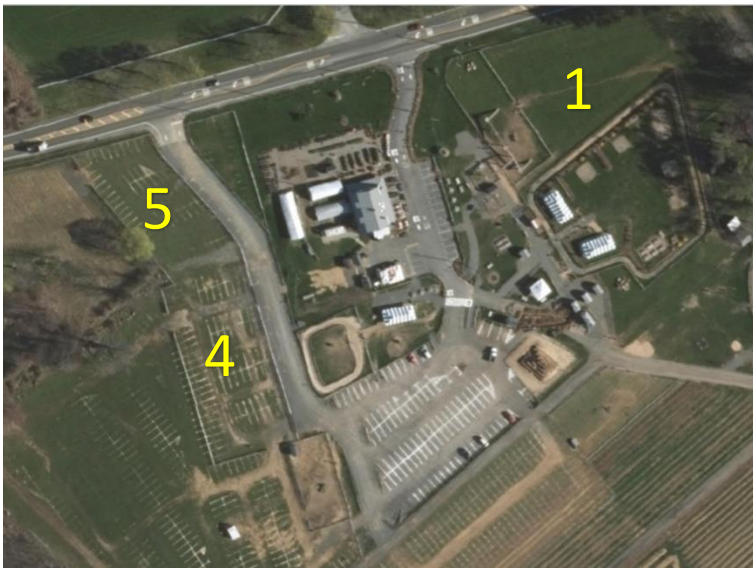
2015

- Per ArcGIS Pro aerial photography between 2013-2015, a pre-existing dirt road (since 2006) that runs perpendicular to Route 24, was partially paved through **Areas 4 and 5**. The road creates a circular traffic pattern to enter and exit the farm. No NJDEP Land Use regulated areas. ***New impervious cover post 2004 approx. 10,500 sqft.***

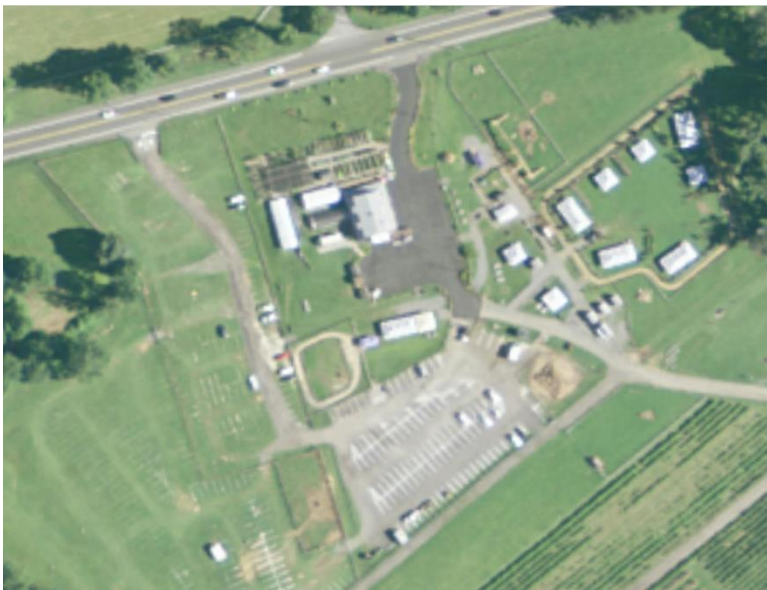
2012

- Per ArcGIS Pro aerial photography between 2010-2012, a pre-existing dirt road (since 1995) that is immediately adjacent to Area 1, was expanded to the north, partially paved, and additional structures were constructed. Adjacent to this road, it appears that multiple farm stands have been added as well as a dirt road, which surrounds the stands for access. This is to the south of Area 1. No NJDEP Land Use regulated areas ***New impervious cover post 2004 approx. 9,000 sqft.***

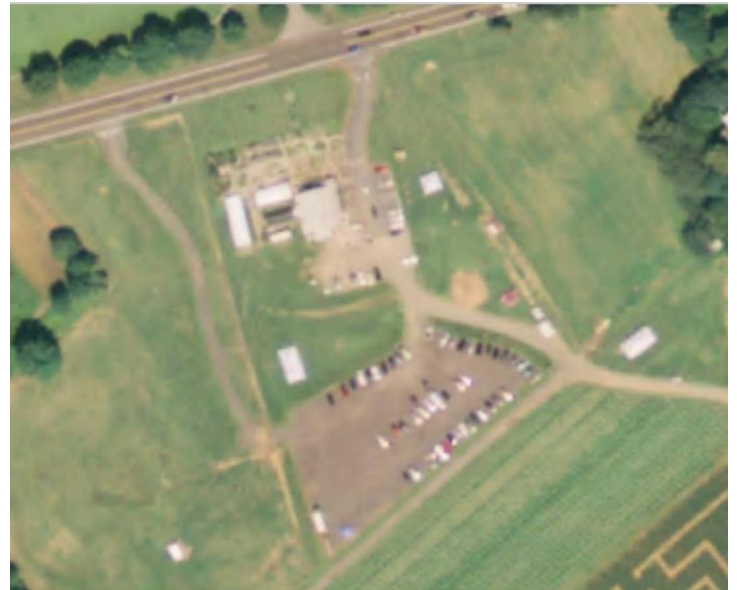
2006

- Per ArcGIS Pro aerial photography, the parking lot immediately behind the barn has been paved sometime after 2006. No NJDEP Land Use regulated areas. ***New impervious cover post 2004 approx. 16,000 sqft, which includes the access road.***
